# Manhole Inspection Summary

Manhole # S43W\_\_D01MH

Record Plat: **43W** Node: **D01** Status: **New Manhole (Not in GIS)** Insp Date: **3/4/08 12:00 AM**

**Location** Address: **1327 lowman st.** Cross Street: **e. clement st**

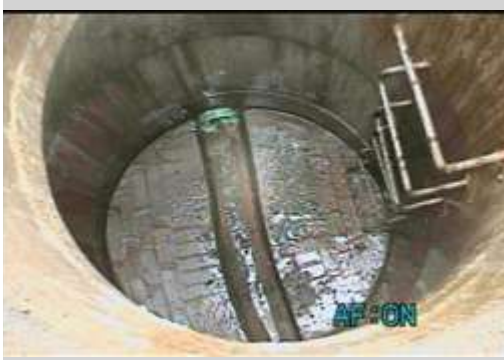
Defect 1

**Corbel** Material: **Precast Concrete** ☐ Parged Type: **Concentric/Eccentric**  
Condition: ☒ Sound ☐ Cracked ☐ Root Intrusion ☐ Loose Brick ☐ Deteriorated  
Infiltration: ☐ None ☐ Joint ☐ Cracks ☐ Mortar ☐ Roots ☒ **Wall**

Infiltration through corbel wall

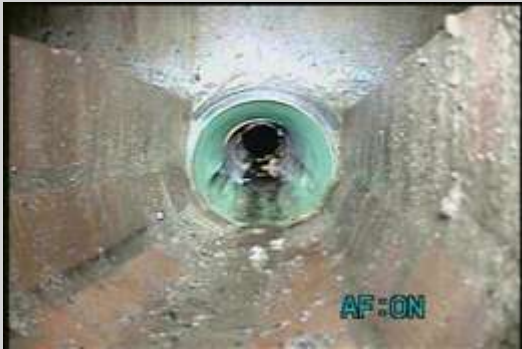
12 O'Clock Outflow

8 in. Circular Gravity Sewer  
Pipe Out @ 12 O'Clock

Invert Depth: 8.50 (ft.) Flow Characteristics: Slow

Infiltration: None

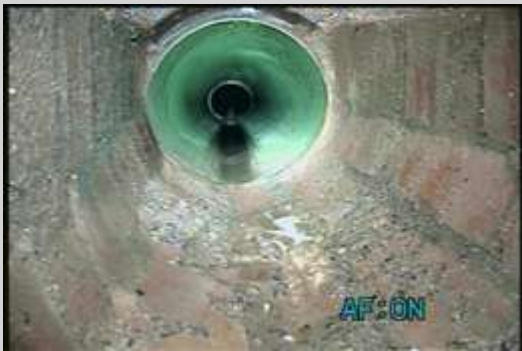
6 O'Clock Inflow

8 in. Circular Gravity Sewer  
Pipe In @ 6 O'Clock

Invert Depth: 8.30 (ft.) Flow Characteristics: Slow

Infiltration: None
